**Flood Control Project Maintenance
Levee Inspections**

Spring 2012 Levee Inspection Results

Yolo County Service Area 6

Waterway			Bank	Unit Miles
Unit No. 01 Right Bank of Sacramento River at Knights Landing			Right	5.97
	Spring (March - May)	Summer (June - August)	(September - November) Fall	Winter (December - February)
Unit Maintenance Rating (Fall Only)				
Date of Inspection	4/17/2012 - 4/17/2012			
DWR Inspector	John Williamson			
Accompanied By	Regina Espinosa Yolo County			
	Chris Starke Yolo County

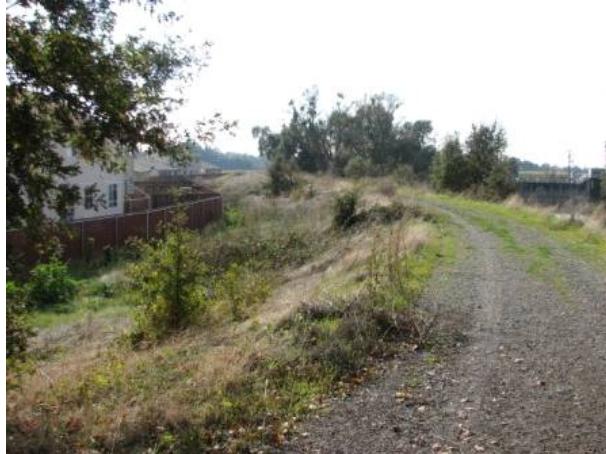
Levee Mile Report Line	4
Start Levee Mile	0.00
End Levee Mile	0.20
Location	Land Side
Category	Earthen Levee
Item	Vegetation
A view of the vegetation on the landside. Grasses are taller than 12 inches. Fall 2011	
johngw_s_20120313_277.jpg

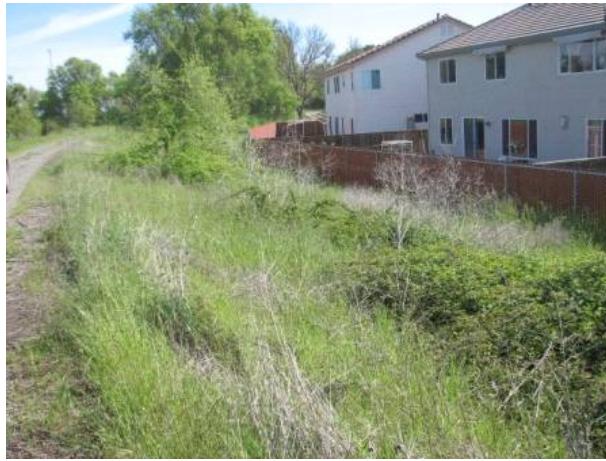
Levee Mile Report Line	4
Start Levee Mile	0.00
End Levee Mile	0.20
Location	Land Side
Category	Earthen Levee
Item	Vegetation
Berries and trees are on the landside levee slope. Photo taken spring 2012.	
johngw_s_20120419_712.jpg

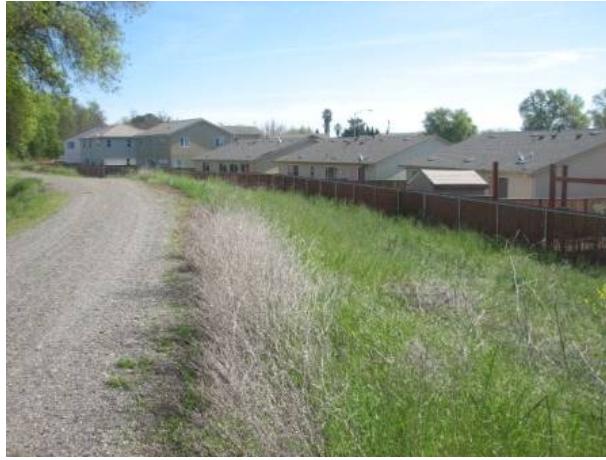
Levee Mile Report Line	5
Start Levee Mile	0.01
End Levee Mile	0.44
Location	Land Side
Category	Earthen Levee
Item	Vegetation
Grasses are taller than 12", photo taken spring 2012.	
johngw_s_20120419_710.jpg

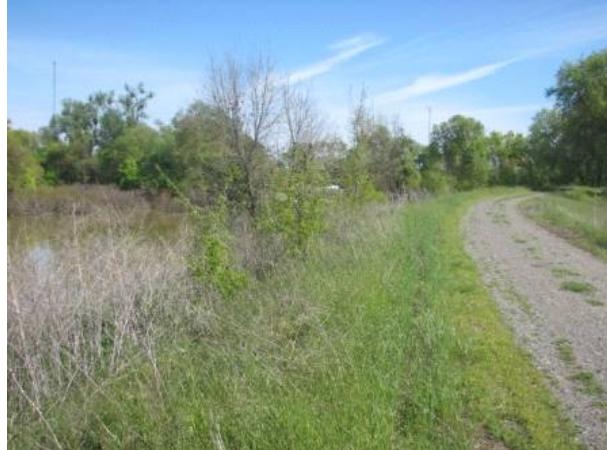
Levee Mile Report Line	6
Start Levee Mile	0.01
End Levee Mile	0.50
Location	Water Side
Category	Earthen Levee
Item	Vegetation
Grasses are taller than 12" photo taken spring 2012.	
johngw_s_20120419_711.jpg

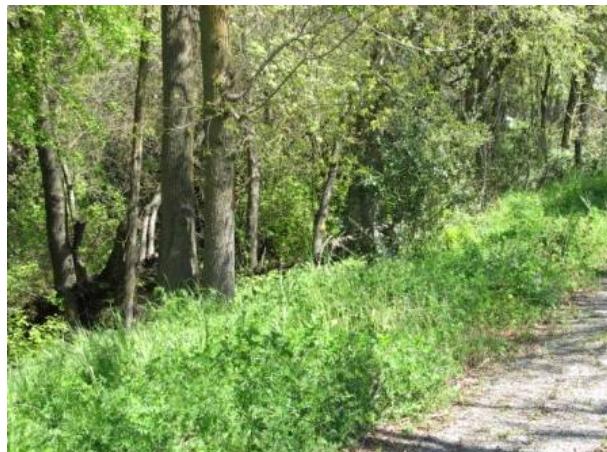
Levee Mile Report Line	7
Start Levee Mile	0.03
End Levee Mile	0.20
Location	Water Side
Category	Earthen Levee
Item	Vegetation
Remove all brush except grasses.	
johngw_s_20120313_242.jpg

7	0.03 0.20	Earthen Levee	Vegetation	WS M Ma	V2 : Remove the wild growth other than native grasses from the levee slopes.			38.799606 ° 38.801368 ° 6 -121.724048 ° -121.722054 ° Y	DWR ID: DWR_NA0022_01_s_2012_6		
8	0.15 0.15	Earthen Levee	Encroachments	LS M En	PR : Prunings			38.800802 ° 38.800802 ° 13 -121.722888 ° -121.722888 ° Y	DWR ID: DWR_NA0022_01_s_2012_13		
9	0.15 0.15	Earthen Levee	Trim / Thin Trees	LS C Ma	T2 : Thin trees to allow visibility of the ground and room to flood fight.			38.800828 ° 38.800828 ° 30 -121.722903 ° -121.722903 °	DWR ID: DWR_NA0022_01_s_2012_30		
10	0.15 0.15	Earthen Levee	Encroachments	WS M En	BU : Buildings			38.800828 ° 38.800828 ° 29 -121.722902 ° -121.722902 ° Y	DWR ID: DWR_NA0022_01_s_2012_29		
11	0.18 0.18	Earthen Levee	Encroachments	LS M En	PR : Prunings			38.801103 ° 38.801103 ° 17 -121.722293 ° -121.722293 ° Y	DWR ID: DWR_NA0022_01_s_2012_17		
12	0.22 0.26	Earthen Levee	Encroachments	LS A/W En	BU : Buildings Inspector Comments: RV park runs on and along levee to bridge			38.801500 ° 38.801613 ° 28 -121.721878 ° -121.721328 ° Y	DWR ID: DWR_NA0022_01_s_2012_28

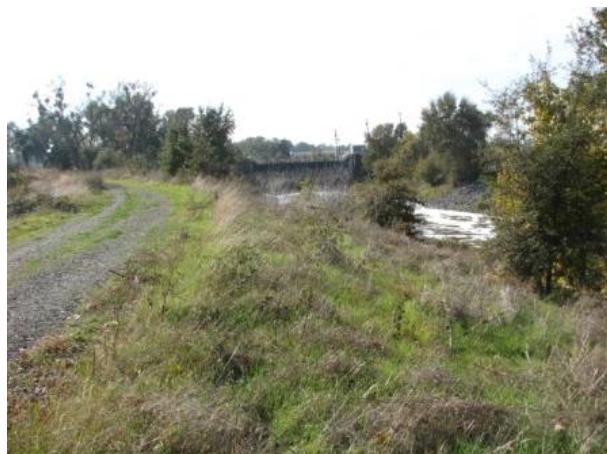
Levee Mile Report Line	7
Start Levee Mile	0.03
End Levee Mile	0.20
Location	Water Side
Category	Earthen Levee
Item	Vegetation
Grasses are taller than 12 inches with brush that obstruct the view. Fall 2011	
johngw_s_20120313_243.jpg

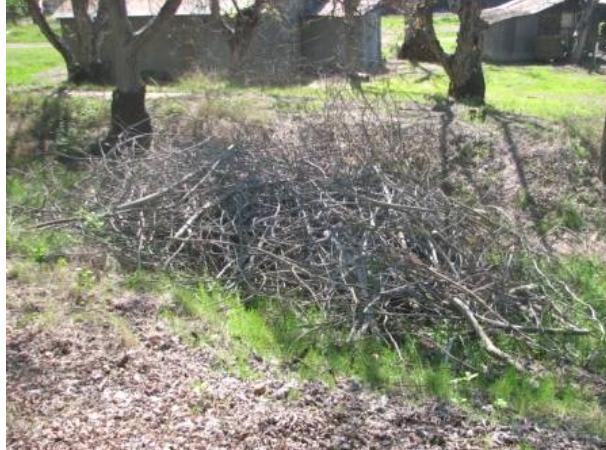
Levee Mile Report Line	8
Start Levee Mile	0.15
End Levee Mile	0.15
Location	Land Side
Category	Earthen Levee
Item	Encroachments
Pruings from the fig tree left at toe. Photo taken spring 2012.	johngw_s_20120419_713.jpg

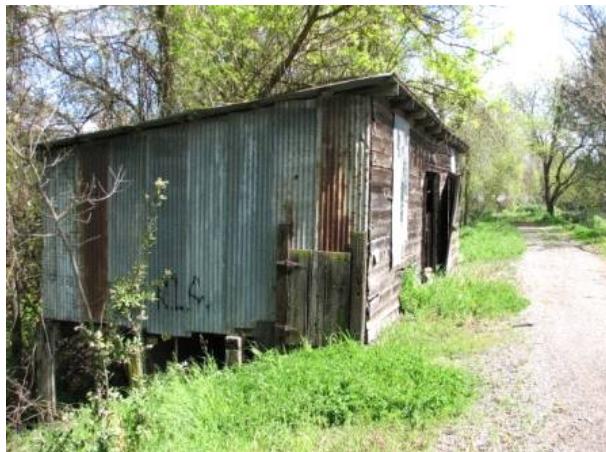
Levee Mile Report Line	10
Start Levee Mile	0.15
End Levee Mile	0.15
Location	Water Side
Category	Earthen Levee
Item	Encroachments
Building on waterside.	johngw_s_20120313_261.jpg

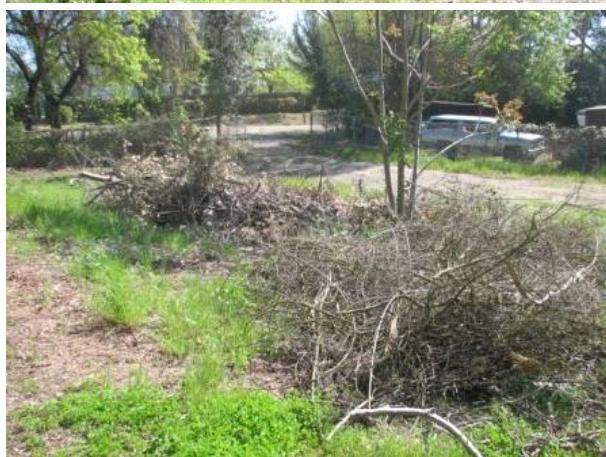
Levee Mile Report Line	11
Start Levee Mile	0.18
End Levee Mile	0.18
Location	Land Side
Category	Earthen Levee
Item	Encroachments
Piles of pruning and debris at toe. Photo taken spring 2012.	johngw_s_20120419_714.jpg

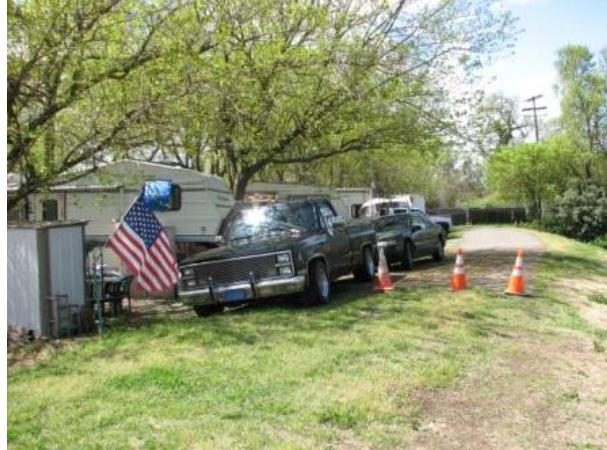
Levee Mile Report Line	12
Start Levee Mile	0.22
End Levee Mile	0.26
Location	Land Side
Category	Earthen Levee
Item	Encroachments
RV park trailers and vehicles on levee.	
<i>johngw_s_20120313_260.jpg</i>

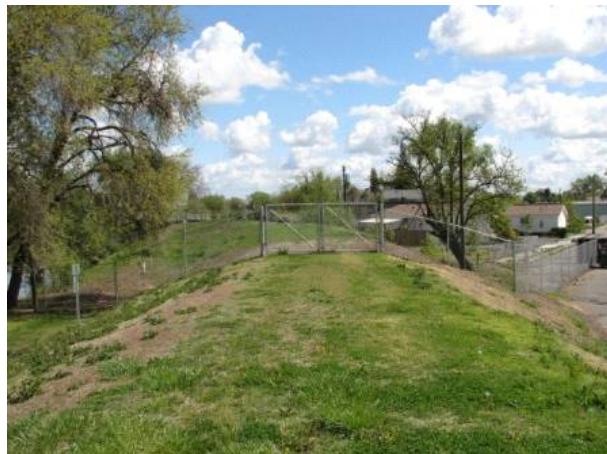
13	0.31 0.33	Earthen Levee	Vegetation	LS A/W En	V6 : Landscaping Inspector Comments: This is a two year old home. I have talked to the owner about a permit and he continues to landscape the landside slope with no permit. Owner has added fence across levee. Gave her an application, did field investigation report.			38.801720 ° 38.801840 ° 27 -121.720447 ° -121.720030 ° Y	DWR ID: DWR_NA0022_01_s_2012_27

Levee Mile Report Line	13
Start Levee Mile	0.31
End Levee Mile	0.33
Location	Land Side
Category	Earthen Levee
Item	Vegetation
Fence across levee.	
<i>johngw_s_20120313_258.jpg</i>

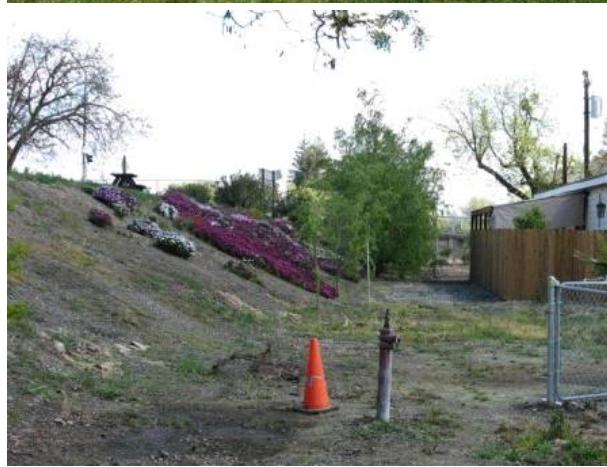
Levee Mile Report Line	13
Start Levee Mile	0.31
End Levee Mile	0.33
Location	Land Side
Category	Earthen Levee
Item	Vegetation
Landscaping on levee slope.	
<i>johngw_s_20120313_259.jpg</i>

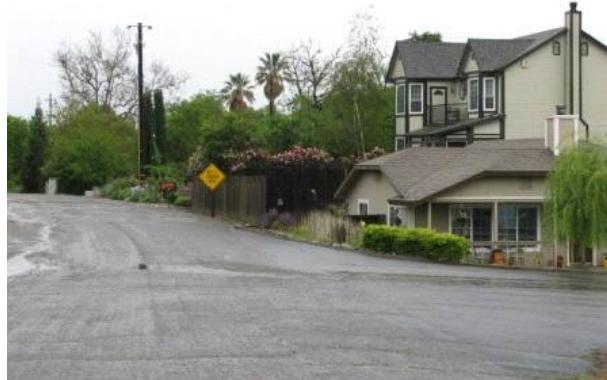
Levee Mile Report Line	17
Start Levee Mile	0.51
End Levee Mile	0.57
Location	Land Side
Category	Earthen Levee
Item	Encroachments
Houses on levee.	johngw_s_20120313_256.jpg

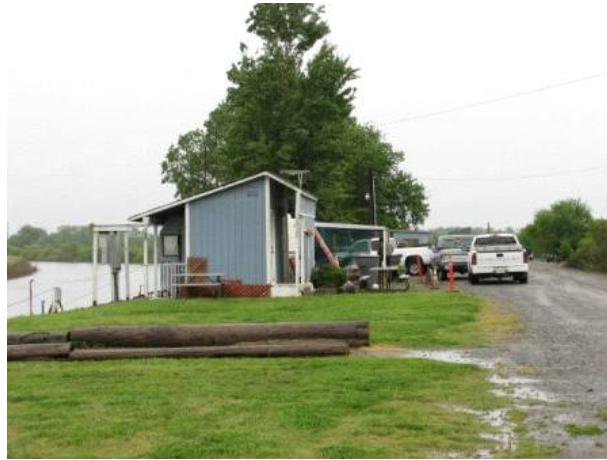
Levee Mile Report Line	19
Start Levee Mile	0.57
End Levee Mile	0.65
Location	Water Side
Category	Earthen Levee
Item	Encroachments
Yacht club	johngw_s_20120313_254.jpg

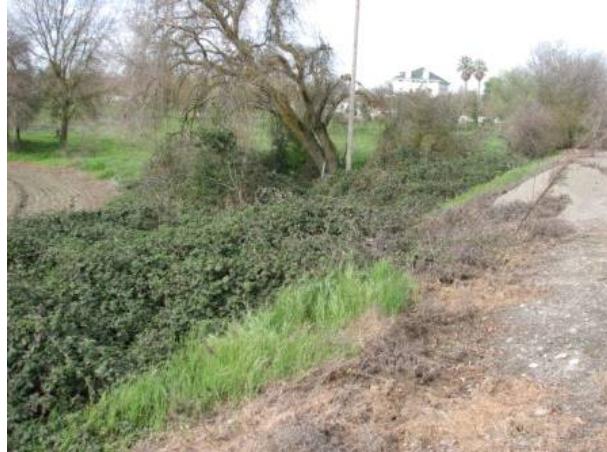
Levee Mile Report Line	20
Start Levee Mile	0.73
End Levee Mile	0.73
Location	Land Side
Category	Earthen Levee
Item	Vegetation
The berry vines block good visibility to see levee slope.	
<i>johngw_s_20120313_233.jpg</i>

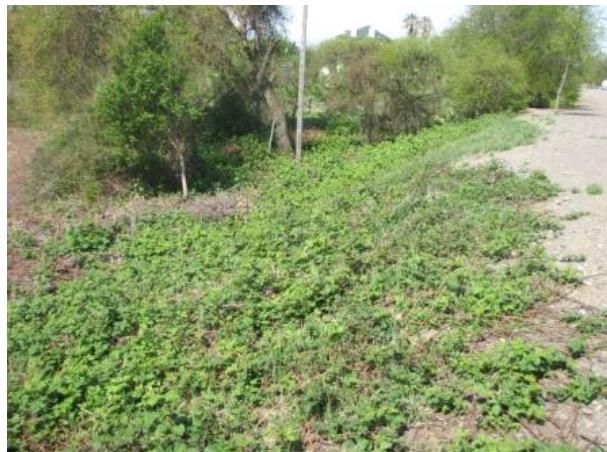
Levee Mile Report Line	20
Start Levee Mile	0.73
End Levee Mile	0.73
Location	Land Side
Category	Earthen Levee
Item	Vegetation
The berries have been grazed down but not killed. Photo taken spring 2012.	
<i>johngw_s_20120419_716.jpg</i>

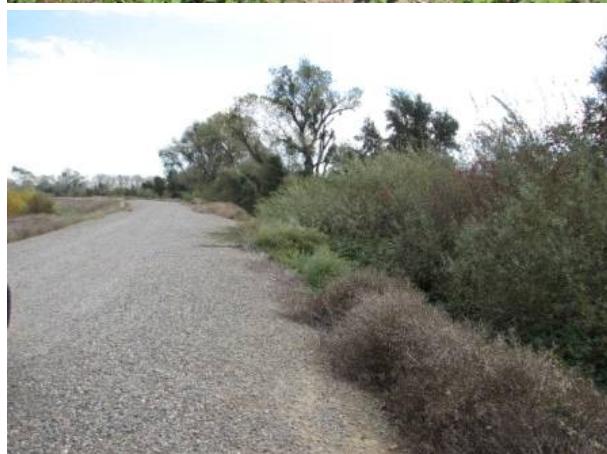
Levee Mile Report Line	21
Start Levee Mile	0.97
End Levee Mile	1.14
Location	Land Side
Category	Earthen Levee
Item	Vegetation
The vegetation completely blocks the view of the levee slope. Fall 2011	
<i>johngw_s_20120313_252.jpg</i>

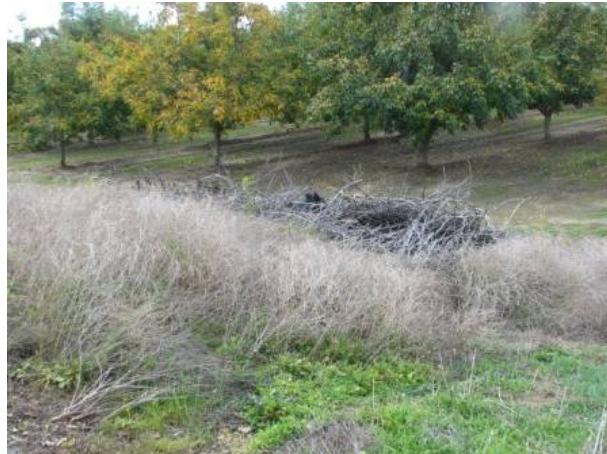
Levee Mile Report Line	25
Start Levee Mile	1.99
End Levee Mile	1.99
Location	Land Side
Category	Earthen Levee
Item	Encroachments
A pile of prunings is stacked on the levee slope near the toe. Fall 2011	
johngw_s_20120313_270.jpg

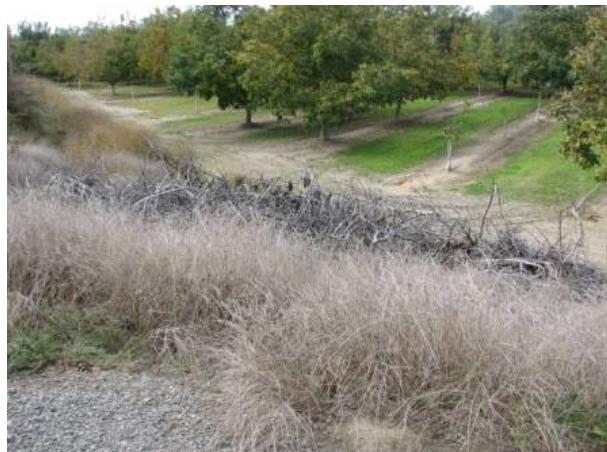
Levee Mile Report Line	26
Start Levee Mile	2.06
End Levee Mile	2.06
Location	Land Side
Category	Earthen Levee
Item	Encroachments
Another pile of prunings is stacked on the levee slope. Fall 2011	
johngw_s_20120313_272.jpg

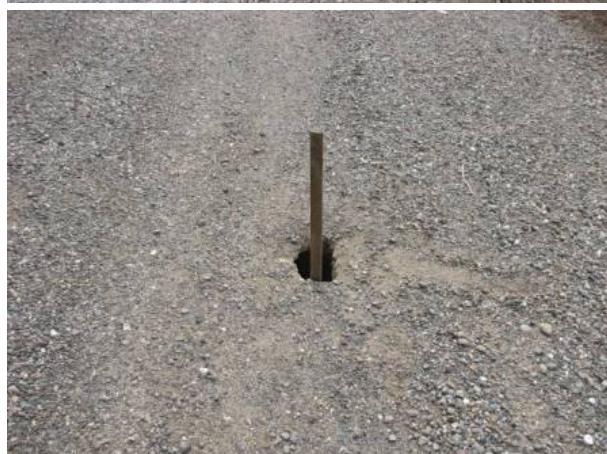
Levee Mile Report Line	27
Start Levee Mile	2.07
End Levee Mile	2.07
Location	Crown
Category	Earthen Levee
Item	Animal Control
A rodent hole in the crown of the levee. Fall 2011	
johngw_s_20120313_273.jpg

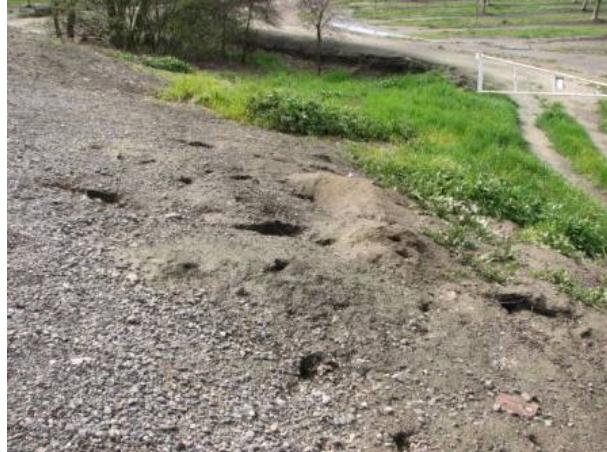
DWR ID: DWR_NA0022_01_s_2012_85
28	2.18	2.18	Earthen Levee	Animal Control	LS M Ma	A3 : No rodents visible, but rodent burrows visible; need to backfill and compact or grout burrows.		38.792956 °	38.792956 °	8	-121.696025 ° -121.696025 ° Y
											DWR ID: DWR_NA0022_01_s_2012_8

Levee Mile Report Line	28
Start Levee Mile	2.18
End Levee Mile	2.18
Location	Land Side
Category	Earthen Levee
Item	Animal Control
There are multiple rodent holes but no visible rodents. Need to backfill and compact.	
johngw_s_20120313_244.jpg

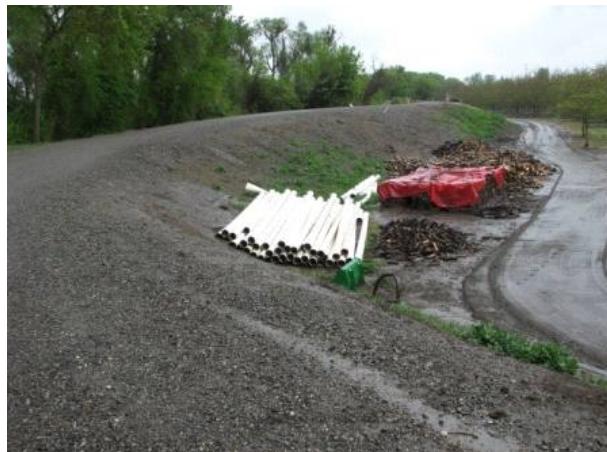
Levee Mile Report Line	29
Start Levee Mile	2.22
End Levee Mile	2.22
Location	Land Side
Category	Earthen Levee
Item	Encroachments
Pipe along toe	
johngw_s_20120313_266.jpg

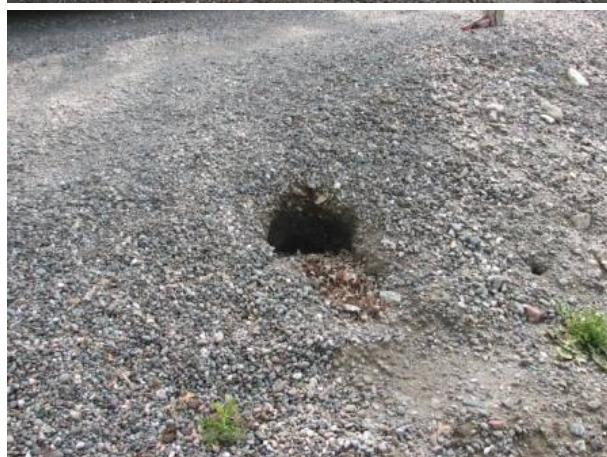
Levee Mile Report Line	30
Start Levee Mile	2.22
End Levee Mile	2.22
Location	Land Side
Category	Earthen Levee
Item	Animal Control
A rodent hole needs to be backfilled and compacted.	
johngw_s_20120313_264.jpg

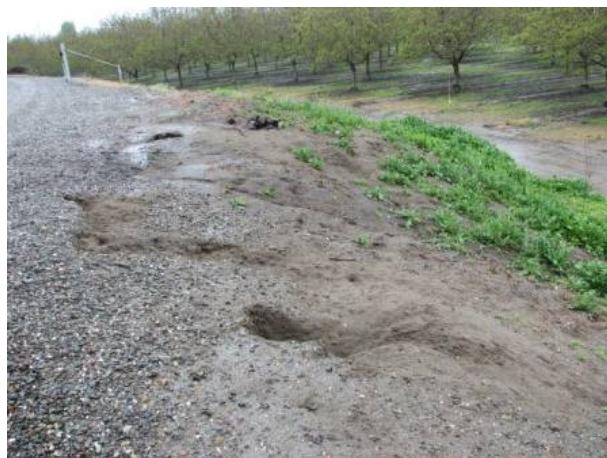
Levee Mile Report Line	32
Start Levee Mile	2.25
End Levee Mile	2.25
Location	Land Side
Category	Earthen Levee
Item	Animal Control

Rodents

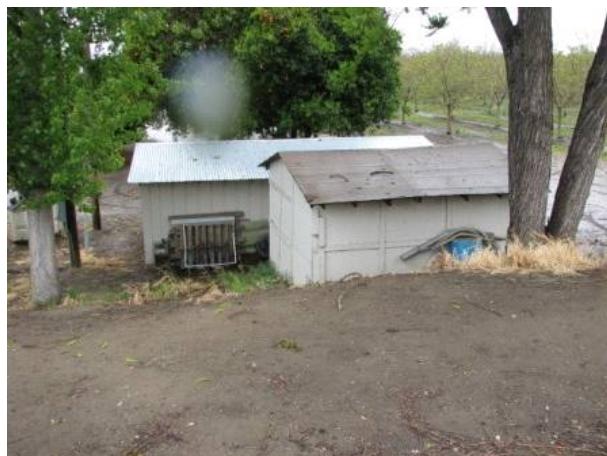
Levee Mile Report Line	34
Start Levee Mile	2.62
End Levee Mile	2.62
Location	Land Side
Category	Earthen Levee
Item	Encroachments

Garage at toe
johngw_s_20120313_246.jpg

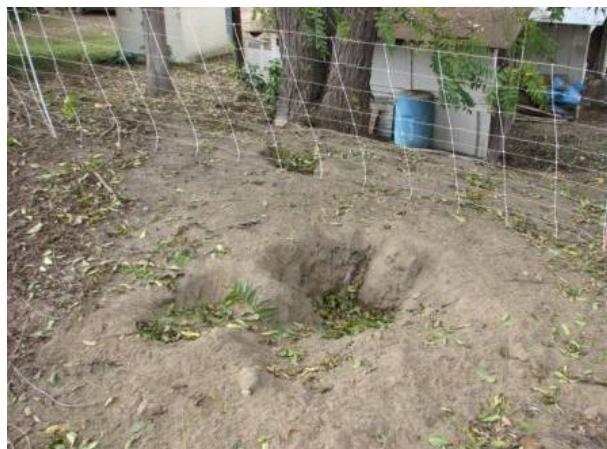
Levee Mile Report Line	35
Start Levee Mile	2.62
End Levee Mile	2.62
Location	Crown
Category	Earthen Levee
Item	Animal Control

A very large rodent hole at the shoulder of the levee. Fall 2011
johngw_s_20120313_274.jpg

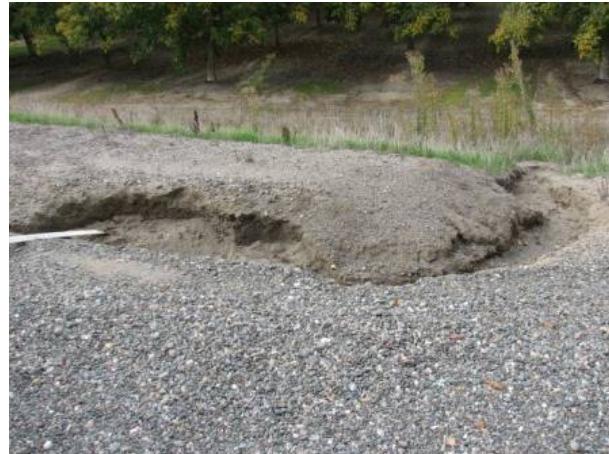
Levee Mile Report Line	36
Start Levee Mile	2.72
End Levee Mile	2.72
Location	Land Side
Category	Earthen Levee
Item	Erosion / Bank Caving
Erosion caused by a build up of water then running off the slope. Fall 2011	
johngw_s_20120313_275.jpg

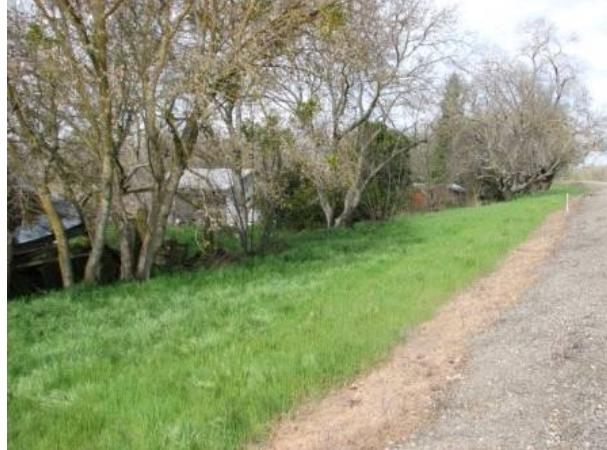
Levee Mile Report Line	39
Start Levee Mile	3.12
End Levee Mile	3.19
Location	Land Side
Category	Earthen Levee
Item	Encroachments
The buildings are encroaching into the levee slope.	
<i>johngw_s_20120313_247.jpg</i>

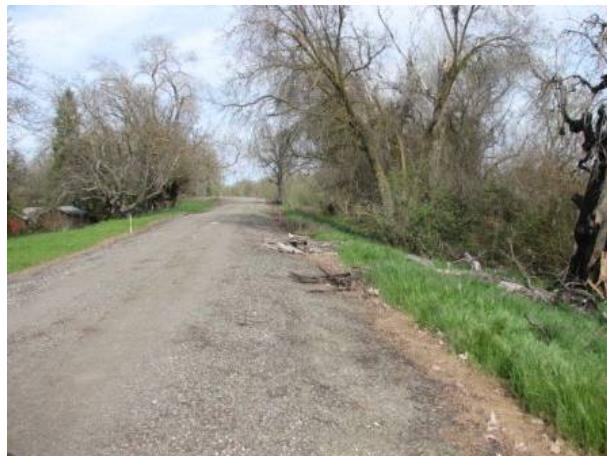
Levee Mile Report Line	40
Start Levee Mile	3.16
End Levee Mile	3.16
Location	Water Side
Category	Earthen Levee
Item	Encroachments
Multiple piles of wooden debris along shoulder along with fallen tree.	
<i>johngw_s_20120313_263.jpg</i>

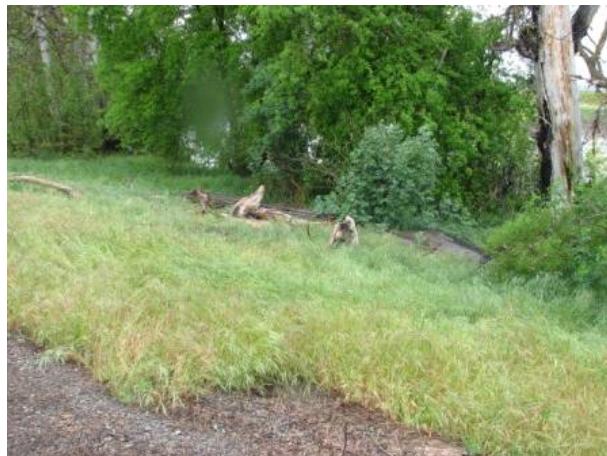
41	3.25	3.25	Earthen Levee	Trim / Thin Trees	WS	M	T3 : Trim and thin trees to allow visibility of the ground and room to flood fight. Inspector Comments: Dead tree broken during winter storms, needs to be cleaned up. Ma	38.780041 °	38.780041 °	15 -121.688499 ° -121.688499 ° Y DWR ID: DWR_NA0022_01_s_2012_15

Levee Mile Report Line	41
Start Levee Mile	3.25
End Levee Mile	3.25
Location	Water Side
Category	Earthen Levee
Item	Trim / Thin Trees
Branches from dead trees, water side	
<i>johngw_s_20120313_248.jpg</i>

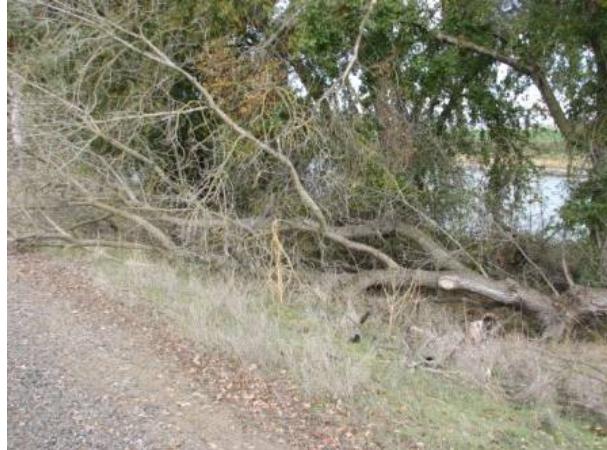
Levee Mile Report Line	42
Start Levee Mile	3.31
End Levee Mile	3.31
Location	Water Side
Category	Earthen Levee
Item	Trim / Thin Trees
A cottonwood tree has fallen over against the slope. Fall 2011	
johngw_s_20120313_249.jpg

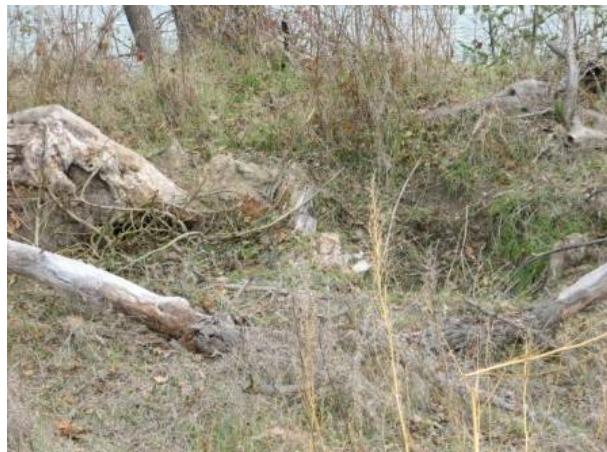
Levee Mile Report Line	42
Start Levee Mile	3.31
End Levee Mile	3.31
Location	Water Side
Category	Earthen Levee
Item	Trim / Thin Trees
This is the root ball of the tree. It has created a large void in the berm. Fall 2011	
johngw_s_20120313_250.jpg

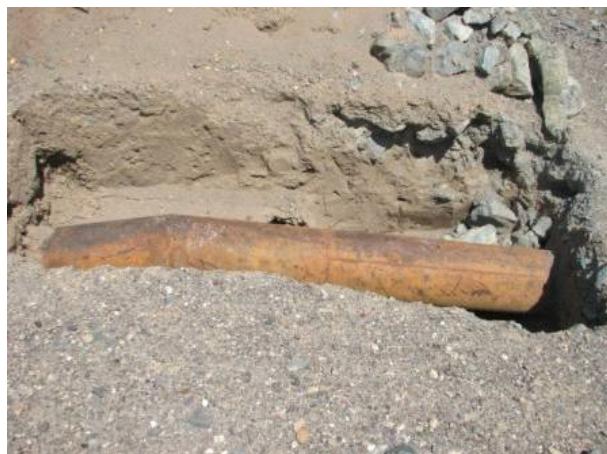
Levee Mile Report Line	43
Start Levee Mile	3.47
End Levee Mile	3.47
Location	Water Side
Category	Earthen Levee
Item	Encroachments
Pipe has been dug up on the waterside shoulder, (Russel, Permit: 3729) photo spring 2012	
johngw_s_20120419_718.jpg

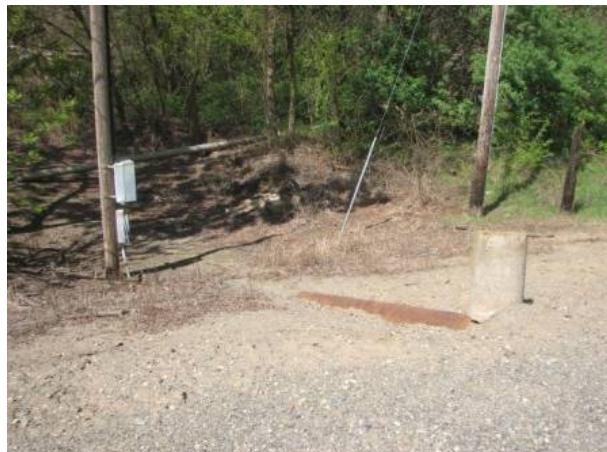
Levee Mile Report Line	43
Start Levee Mile	3.47
End Levee Mile	3.47
Location	Water Side
Category	Earthen Levee
Item	Encroachments
Landside view of the ppe.	
<i>johngw_s_20120419_720.jpg</i>

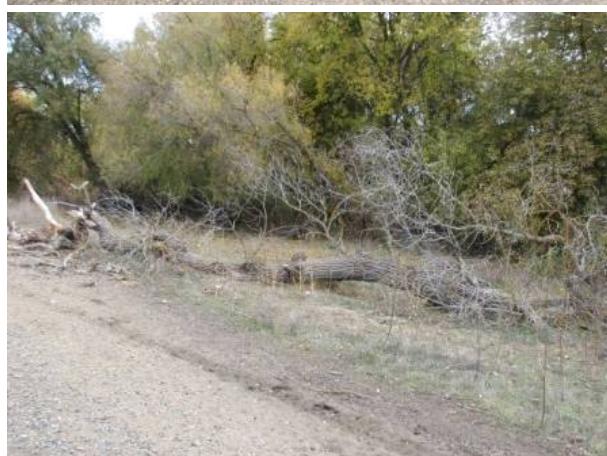
Levee Mile Report Line	44
Start Levee Mile	3.70
End Levee Mile	3.70
Location	Water Side
Category	Earthen Levee
Item	Encroachments
Another tree has fallen on the waterside slope. Fall 2011	
<i>johngw_s_20120313_276.jpg</i>

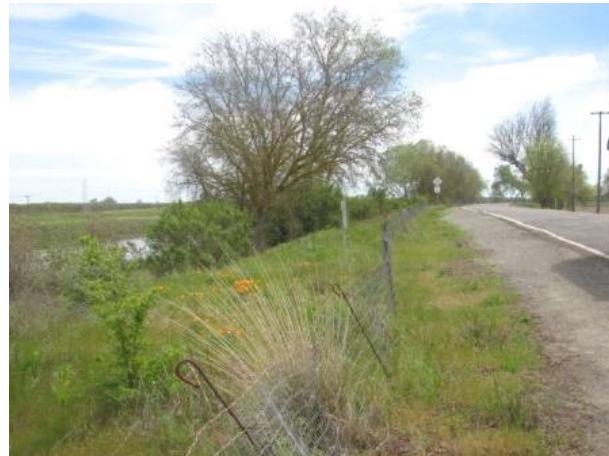
Levee Mile Report Line	45
Start Levee Mile	4.31
End Levee Mile	4.57
Location	Water Side
Category	Earthen Levee
Item	Vegetation
Another view of the site.	
johngw_s_20120419_723.jpg

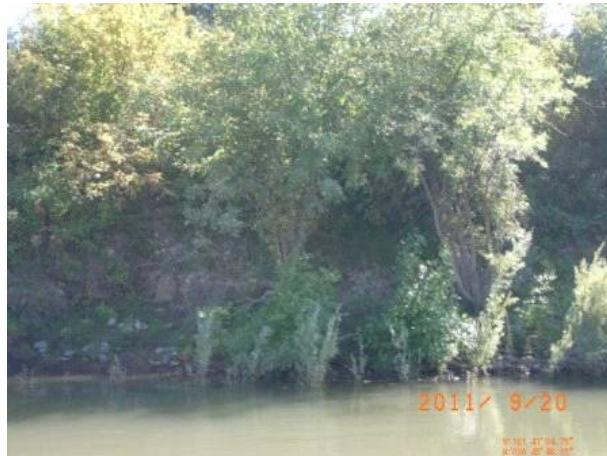
Levee Mile Report Line	46
Start Levee Mile	4.65
End Levee Mile	4.86
Location	Water Side
Category	Supplemental
Item	USACE Erosion Survey

46	4.65	4.86	Supplemental USACE Erosion Survey		WS M Ma	Inspector Comments: 2009 - Erosion into the levee toe. Some cobbles have been dumped into the erosion pockets. 2010 - Old cobble site starting to unravel. 2011: No observed change. [2011 Site ID: SAC_85-4_R]	38.763486 ° -121.687567 °	38.763313 ° -121.684038 °	Y	DWR ID: DWR_NA0022_01_s_2012_4	
47	5.60	5.65	Earthen Levee	Encroachments	LS A/W En	BU : Buildings	38.759620 ° -121.673903 °	38.759412 ° -121.673167 °	Y	DWR ID: DWR_NA0022_01_s_2012_1	
48	5.76	5.86	Supplemental USACE Erosion Survey		WS M Ma	Inspector Comments: 2006 - Approximately 18 to 20 ft of bank near levee at the corner of the levee and the Freemont Weir. Vertical bank with undercutting/mass failure. 2007 - Staked at top of bank for monitoring. 2011: Site has become significantly worse with more of the toe and lower bank eroded. Many trees have fallen since last year. [2011 Site ID: SAC_83-9_R]	38.758948 ° -121.669103 °	38.759390 ° -121.667500 °	Y	DWR ID: DWR_NA0022_01_s_2012_5

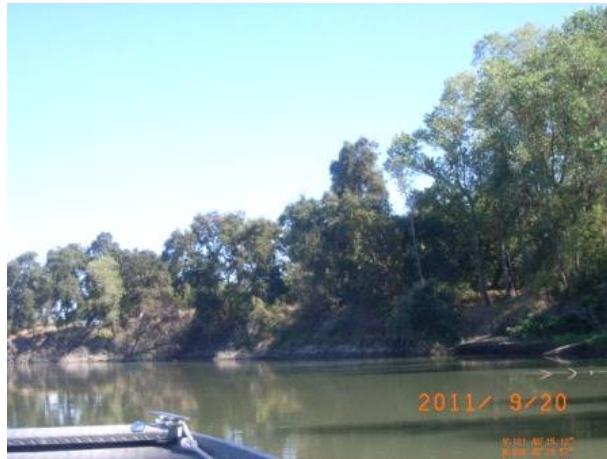
Levee Mile Report Line	48
Start Levee Mile	5.76
End Levee Mile	5.86
Location	Water Side
Category	Supplemental
Item	USACE Erosion Survey
USACE 2011 Photo #1	
johngw_s_20120313_239.jpg

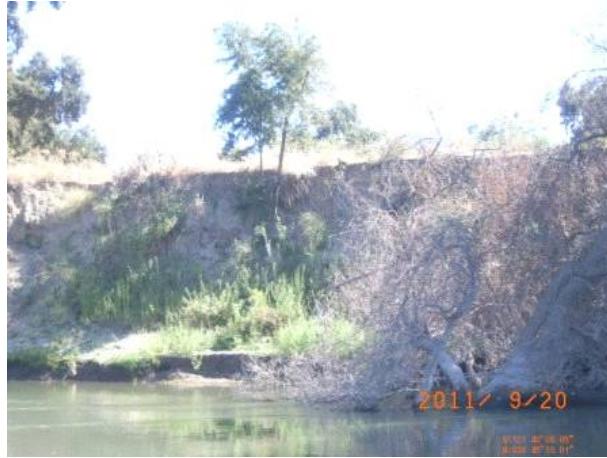
Levee Mile Report Line	48
Start Levee Mile	5.76
End Levee Mile	5.86
Location	Water Side
Category	Supplemental
Item	USACE Erosion Survey
USACE 2011 Photo #2	
johngw_s_20120313_240.jpg
